2018 Dam Failures in the Coon Creek and West Fork Kickapoo Watersheds in Southwestern Wisconsin

A Summary of NRCS Technical Reports

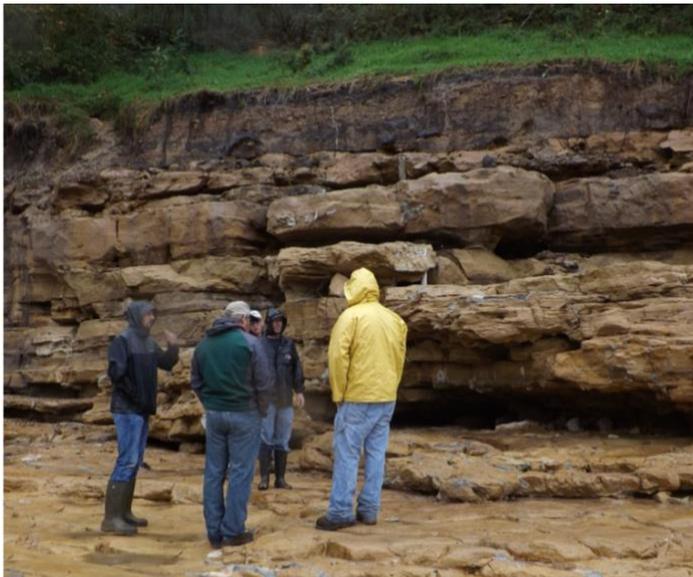
- **Aging infrastructure:** Original design assumptions and materials have degraded over more than 60 years in service.
- **Geologic concerns:** Foundation seepage and springs were documented at multiple West Fork Kickapoo dams, leading to grout curtain installations and continued monitoring of abutment stability (Figure 2).
- **Internal erosion risk:** Filter and drain systems predate modern criteria and may not provide adequate protection against internal erosion under high hydraulic stress.
- **Hydrologic undersizing:** Principal spillways were designed for approximately 4.6 inches (Coon Creek) and 3.9 inches (West Fork Kickapoo) of rainfall in six hours—estimates considered ~50–100-year storms based on mid-20th-century rainfall science.

Figure 2. Close-up of exposed bedrock at the right abutment of West Fork Kickapoo Dam 1 after the dam failed during the 2018 flood. Fractures in the bedrock and large exposed cavities show geological weaknesses in the dam foundation and provide an example of geological problems present at failed dams in the watershed (NRCS, 2019).

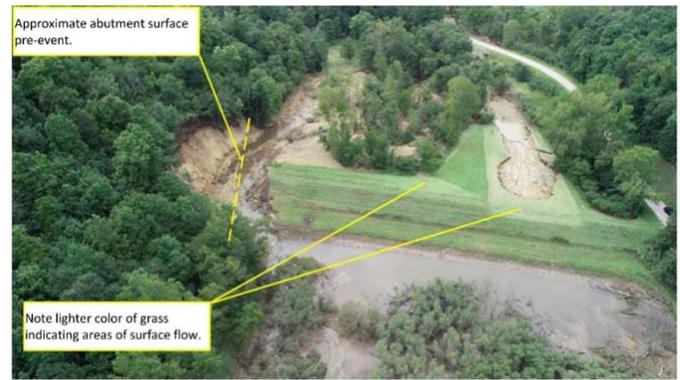
- **Earthen emergency (auxiliary) spillways:** Emergency spillways were constructed as unarmored soil channels (e.g., not concrete-lined), making them inherently vulnerable to rapid erosion if heavily engaged during extreme floods (Figure 3).

Figure 3. Aerial view of the eroded earthen emergency spillway (right side of the dam) at Coon Creek Dam 29. This spillway is representative of the unarmored soil emergency spillways, which are vulnerable to rapid erosion when activated by large floods (NRCS, 2019).
