2018 Dam Failures in the Coon Creek and West Fork Kickapoo Watersheds in Southwestern Wisconsin

A Summary of NRCS Technical Reports

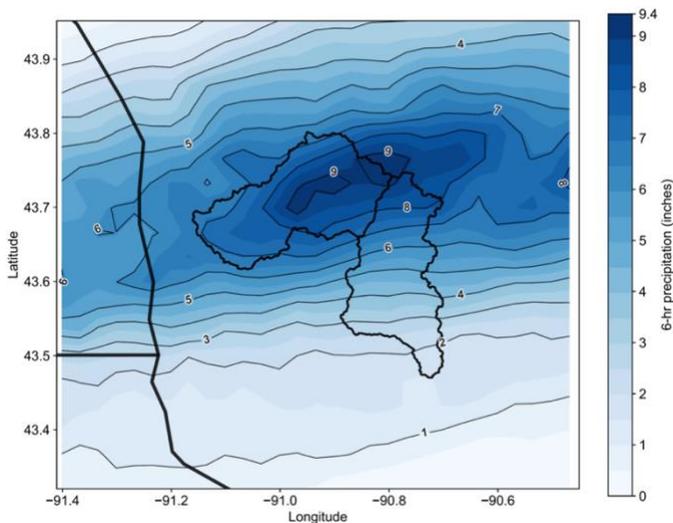
On the night of August 27–28, 2018, a highly localized convective storm system stalled over the upper portions of the Coon Creek and West Fork Kickapoo watersheds, producing 6–7 hours of intense rainfall. Maximum 6-hour precipitation totals for both watersheds are presented in Figure 4. Point rainfall depths exceeding 9 inches in Coon Creek and 8 inches in West Fork Kickapoo far surpassed the mid-20th-century principal spillway design thresholds (4.6 inches and 3.9 inches, respectively). As a result, the principal outlets could not pass the inflow, and the emergency spillways were activated at the affected sites. In the Coon Creek watershed, storm magnitudes were also large enough to exceed emergency spillway design thresholds and ultimately challenged freeboard limits, leading to overtopping and embankment erosion at multiple structures. At WFK-1, the rainfall exceeded emergency spillway design capacity without reaching the crest, forcing substantial uncontrolled flow through the earthen emergency spillway. The breach then initiated within the emergency spillway on the left abutment side of the dam, where seepage and foundation weaknesses had previously been identified.

Figure 4. Six-hour precipitation (inches) during the 9 PM–3 AM period of the 27–28 August 2018 storm. The left watershed is Coon Creek and the right watershed is West Fork Kickapoo. Rainfall amounts are shown using both color shading and contour lines. Precipitation data are from the Analysis of Record for Calibration (AORC).
