2018 Dam Failures in the Coon Creek and West Fork Kickapoo Watersheds in Southwestern Wisconsin

A Summary of NRCS Technical Reports

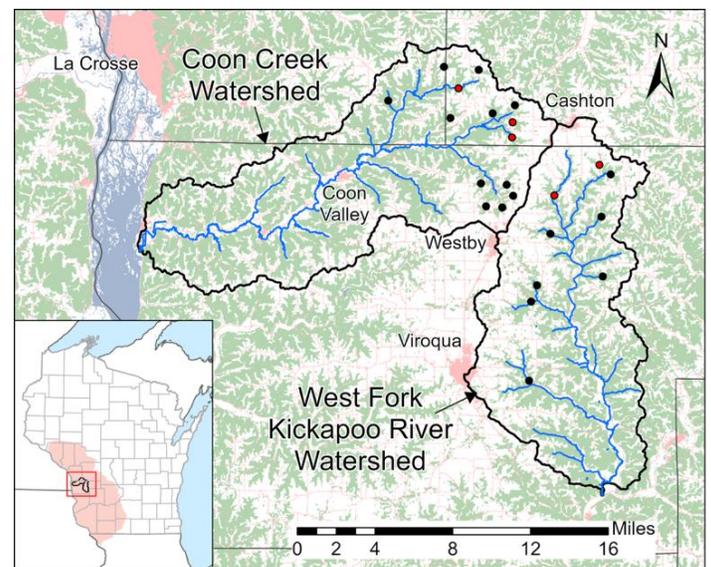
Figure 1. The Coon Creek and West Fork Kickapoo watersheds and the locations of dams (filled circles). Dams that failed during the 2018 flood event are shown as red circles.

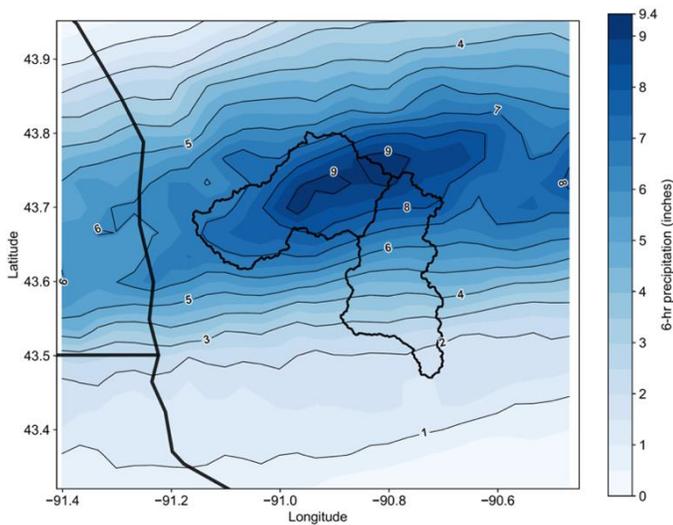
Figure 4. Six-hour precipitation (inches) during the 9 PM–3 AM period of the 27–28 August 2018 storm. The left watershed is Coon Creek and the right watershed is West Fork Kickapoo. Rainfall amounts are shown using both color shading and contour lines. Precipitation data are from the Analysis of Record for Calibration (AORC).
